## Property Condition Assessment

12/5/2022

# PROJECT SUMMARY

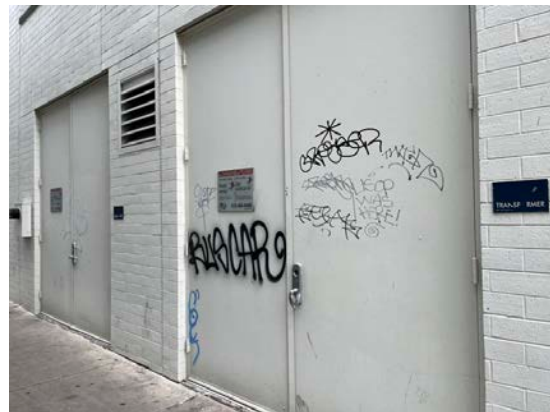
| Item | Description | Rating | Action |
|---|---|---|---|
| Evidence of Vandalism or Graffiti? | Evidence of graffiti was observed on a steel exterior door on the building's south elevation. | Fair | ST |

Evidence of graffiti was observed on a steel panel exterior door on the building's south elevation. We would recommend removal or repainting of the door's surface area.

Graffiti

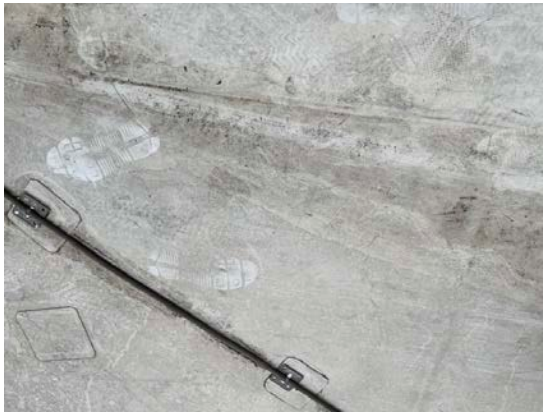
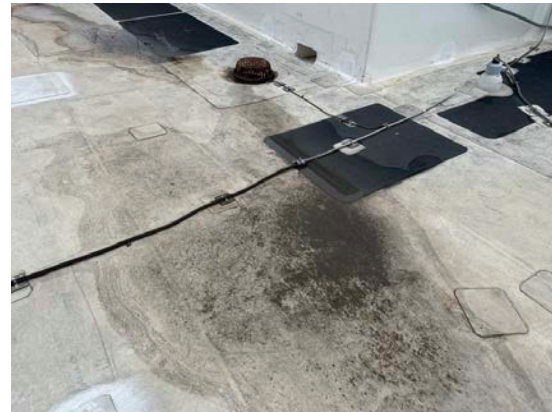
Roof mounted equipment includes (2) freestanding CMU block structures that house the elevator mechanical room and boiler room. Additional roof mounted equipment includes the building's cooling tower and ventilation fans. Significant water ponding or debris was not observed on the roof surface. Evidence of active or historical roof leaks were not observed in the building interiors. We were advised a roof warranty is in place; however the only warranty document provided by the property management was an exterior renovations general warranty that expired February 2022. The roof appears to be original to the building, but well within the expected useful life (EUL) of a TPO roof covering.

Roof-Area of Concern

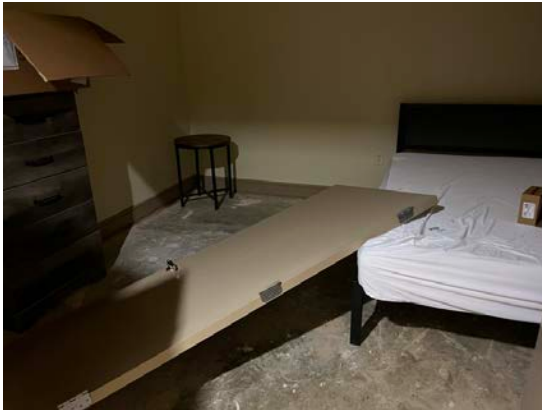
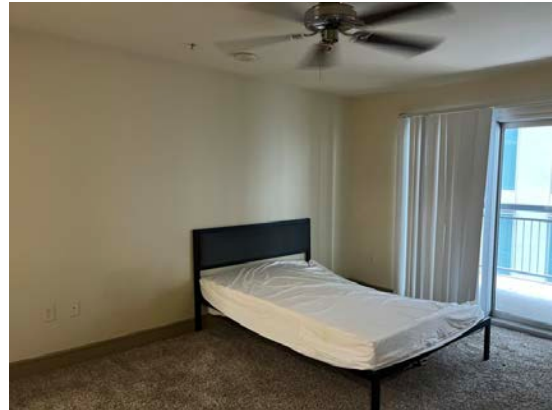
Unit 12006

| Item | Quantity | Unit | Unit Cost | Replacement Percent | Immediate Total | Short Term Total |
|---|---|---|---|---|---|---|
| Carpet Replacement - Units 12006 and 13010 | 1,200 | EA | \$3.50 | 100% | \$4,200 | |

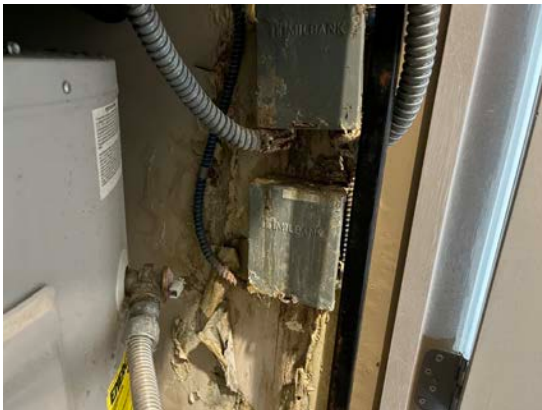
| Item | Quantity | Unit | Unit Cost | Replacement Percent | Immediate Total | Short Term Total |
|---|---|---|---|---|---|---|
| Gypsum Board Replacement - Unit 12009 | 1 | EA | \$1,000.00 | 100% | \$1,000 | |

the base of each water heater unit. Interior wall damage from a previously leaking water heater and water source heat pump was observed in the HVAC closet of Unit #12009. Bathroom amenities include a prefabricated wood vanity with sink, a fiberglass shower unit or a bathtub/shower combo unit, and a standard grade toilet with seat.

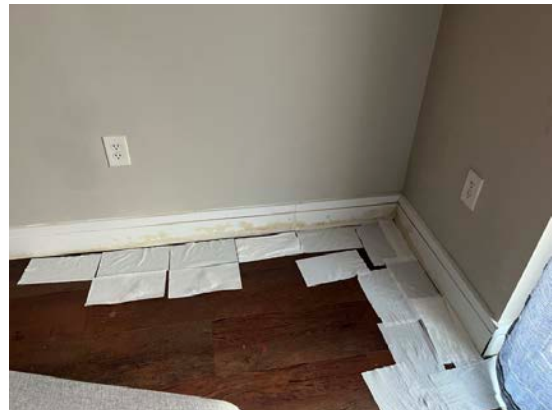
| Item | Quantity | Unit | Unit Cost | Replacement Percent | Immediate Total | Short Term Total |
|---|---|---|---|---|---|---|
| Flooring/Baseboards Repair - Unit 7003 | 1 | EA | \$1,500.00 | 100% | \$1,500 | |

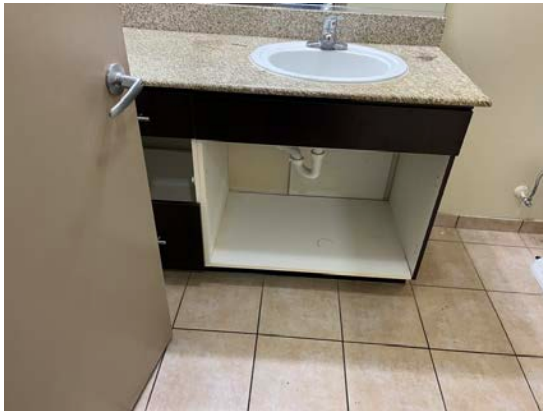
| Item | Quantity | Unit | Unit Cost | Replacement Percent | Immediate Total | Short Term Total |
|---|---|---|---|---|---|---|
| Lavatory Replacement - Unit 12006 | 1 | EA | \$1,100.00 | 100% | \$1,100 | |

Bathroom Lavatory - Unit 12006

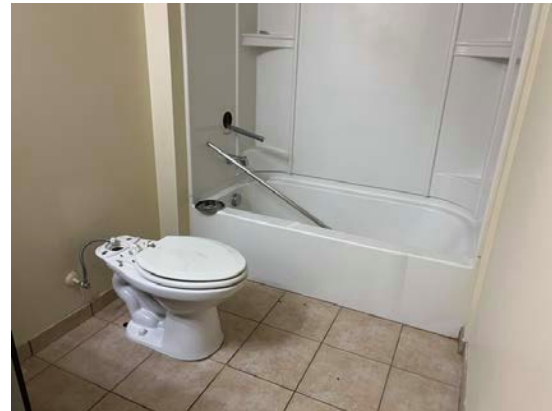
Toilet - Unit 12006
