## Phase I Environmental Site Assessment

October 4, 2023

23329-99

Site Size: 9.729 acres  
 Property Type: Multi-family Apartments  
 Building Size: +/- 317,786

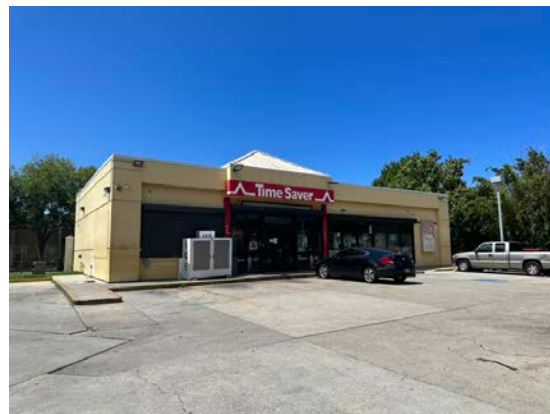
The adjoining Chevron facility to the east poses a recognized environmental condition (REC) to the Subject Property based on historical releases, residual contamination, and a history of violations. However, the facility has undergone remediation to rectify the situation, and per the [REDACTED] ([REDACTED]), has affectively addressed the releases and violations. MCC recommends an annual monitoring of records over time, particularly in consideration of historical concerns, the age of the tanks, existing residual contamination, and a significant track record of past violations associated with the adjoining facility. At this juncture, no further actions are deemed necessary. This monitoring aligns and serves as a precautionary measure given the historical violations and incidents of tank releases associated with the adjoining property and their operational practices.

East Adjacent - Chevron Gas Station and Time Saver

- Regarding the adjoining Chevron facility to the east, MCC recommends an annual monitoring of records over time, particularly in consideration of historical concerns, the age of the tanks, existing residual contamination, and a significant track record of past violations associated with the adjoining facility. At this juncture, no further actions are deemed necessary. This monitoring aligns and serves as a precautionary measure given the historical violations and incidents of tank releases associated with the adjoining property and their operational practices.

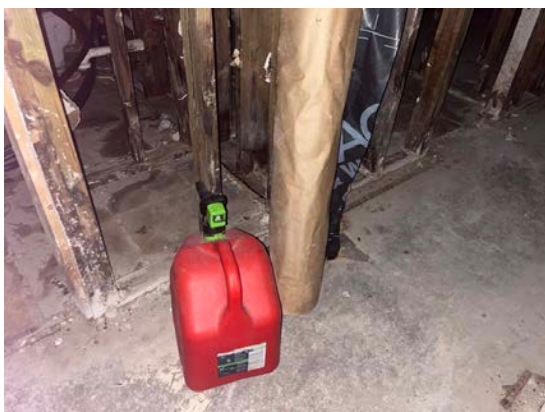
During the assessment, small red storage cans containing what appeared to be gasoline were identified in Units 104 and 241. The purpose of these containers was not documented or reported. Hazardous materials, such as gasoline, must either be stored in a designated flammable materials storage cabinet if they are actively used on the property, or they should be properly disposed of in accordance with regulations.

Unit 241 Gas Can

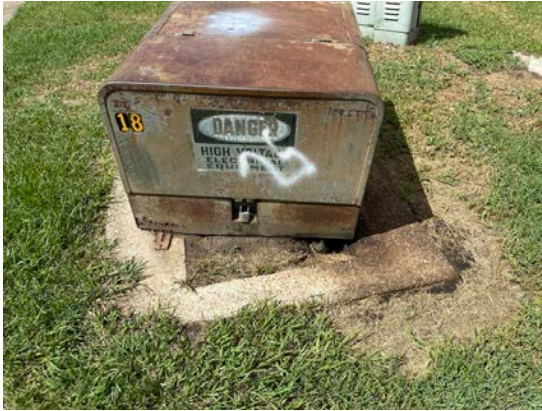
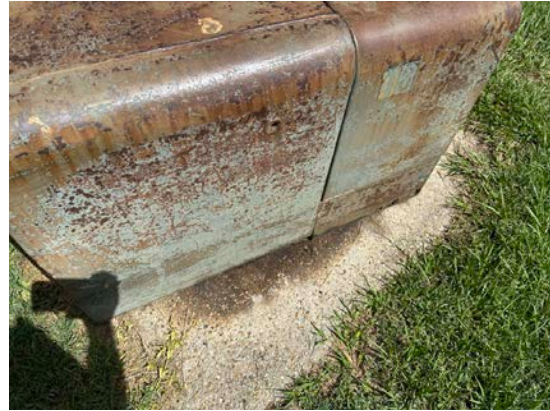
| Report Section | | Acceptable | REC | HREC | CREC | De<br>Minimis | BER | Notes |
|---|---|---|---|---|---|---|---|---|
| 6.1.5 | <u>Transformers or PCB-Containing Equipment/Items</u> | | ✓ | | | | | Concrete staining and distressed vegetation was identified around one transformer in-between Buildings 14 and 16 and is identified as a REC. |

The Subject Property has underground electrical service with pad-mounted transformers owned by [REDACTED], a public utility provider. There was observed apparent leakage from one transformer between Buildings 14 and 16, as evidenced by stained concrete and distressed vegetation around the transformer. This transformer potentially contains PCBs due to its age, as the property was built in 1973. While one transformer had a 2016 manufacturer date, no dates were found on the smaller, older-looking transformers. [REDACTED] could not confirm if the smaller transformers contain PCBs. Since the absence of PCBs within the transformer could not be confirmed, it represents a Recognized Environmental Condition (REC). MCC recommends the identified release of dielectric fluid be reported to [REDACTED] and that [REDACTED] determine the manufacturing date and conduct appropriate response actions to remove the impacted concrete pad and any underlying impacted soil. If PCBs are present, MCC additionally recommends that post-excavation confirmatory soil samples be collected and analyzed for the presence of total petroleum hydrocarbons (TPH) and polychlorinated biphenyls (PCBs). Periodic inspections of other units for leakage are recommended. No other equipment using dielectric or hydraulic fluid was found during the site assessment.

Apparent Leaking Transformer

- The Subject Property has underground electrical service with pad-mounted transformers owned by [REDACTED], a public utility provider. There was observed apparent leakage from one transformer between Buildings 14 and 16, as evidenced by stained concrete and distressed vegetation around the transformer. This transformer potentially contains PCBs due to its age, as the property was built in 1973. MCC recommends the identified release of dielectric fluid be reported to [REDACTED] and that [REDACTED] determine the manufacturing date and conduct appropriate response actions to remove the impacted concrete pad and any underlying impacted soil. If PCBs are present, MCC additionally recommends that post-excavation confirmatory soil samples be collected and analyzed for the presence of total petroleum hydrocarbons (TPH) and polychlorinated biphenyls (PCBs). Periodic inspections of other units for leakage are recommended.

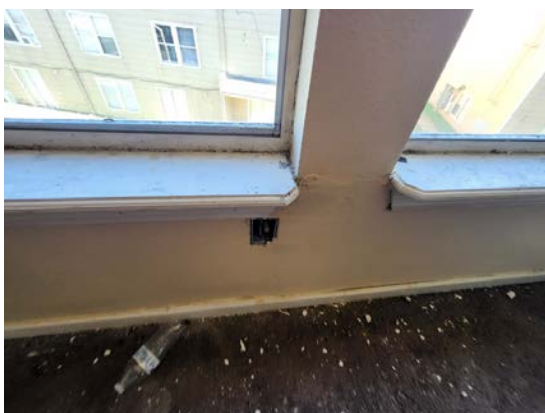
Based on the age of the Subject Property, the potential for the presence of ACMs exists. MCC conducted a limited screening survey for the presence of ACM at the Subject Property. MCC collected 12 bulk samples of suspect materials. The samples taken were located in the leasing office and Unit 263. The results indicated that asbestos was not detected in the sampled materials. Previous hurricanes and other forms of water intrusion were reported and observed where interior drywall replacement has been necessary on all floors. With the uncertainty of which the drywall was replaced, if at all, an extensive Asbestos Survey may reveal different results. Please note that the scope of work for this survey was limited to a sample of friable materials or damaged non-friable materials in a few accessible areas and that destructive sampling of undamaged non-friable materials was not conducted.

Caulking (Suspect ACM)

- MCC recommends comprehensive testing and removal of damaged asbestos following state and local regulations. Additionally, MCC recommends an asbestos inspection be performed in accordance with all applicable federal, state, and local regulatory requirements prior to renovation, demolition, or other activities that could cause a material disturbance. Any removal or disturbance of ACM or suspect ACM should be performed by properly trained personnel and in compliance with federal, state, and local regulations. MCC further recommends the implementation of an Asbestos Operations and Maintenance (O&M) Program. This O&M Plan provides the procedures and guidelines that, when used during facility cleaning, maintenance, and general operations, will minimize human exposure to asbestos fibers and minimize release of asbestos fibers to the environment. This O&M Plan is a long term management approach.

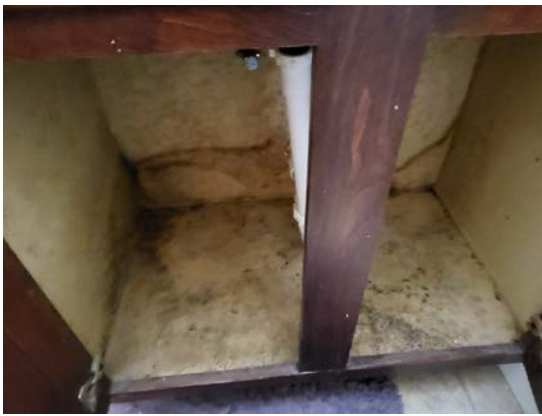
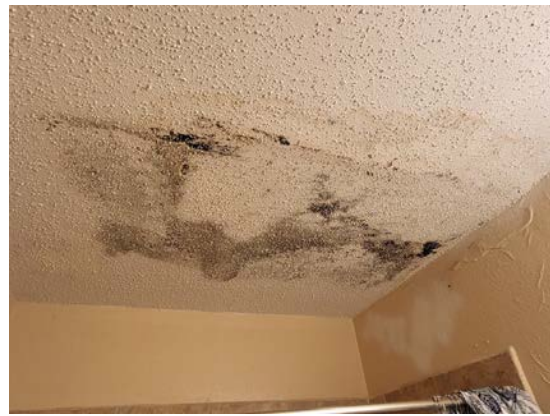
Evidence of water intrusion and microbial growth was observed within a majority of the observed units, both occupied and vacant/down units, as well as the common area laundry facilities. The observed microbial growth was present along the drywall ceilings and walls, insulation, within the cabinetry, and along the structural members of the buildings. The observed microbial growth appeared to have been sustained from water damage of a variety of sources, including roof leaks, plumbing leaks, condensate line leaks, and other forms of water intrusion events. Property management appeared to have repaired some of the issues; however, some areas of water intrusion remain active. Microbial growth remediation did not appear to be a standard practice at the Subject Property. Due to the apparent lack of proper remediation, it is reasonable to assume that further microbial growth is present in areas of the buildings that were covered and were unable to be observed.

Unit Apparent Microbial Growth

MCC recommends a Mold assessment be completed at the property to determine the extent of the growth. Given the extent of affected areas at the Subject Property, MCC further recommends the implementation of a Mold Operation and Maintenance (O&M) Plan be prepared for the Subject Property. A Mold O&M Plan is intended for the owners, employees, and occupants of the Subject Property for their use in controlling the microbial growth and water damaged materials in the building. The O&M Plan provides procedures and guidelines, that used during facility cleaning, maintenance, and general operations, will minimize human exposure to mold and fungus and prevent mold growth due to water damage. A Mold O&M Plan is a long-term management approach and is intended to cover maintenance procedures related to microbial growth, mold, and water damage.

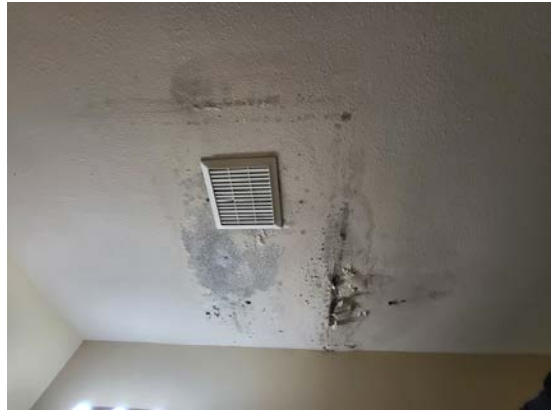
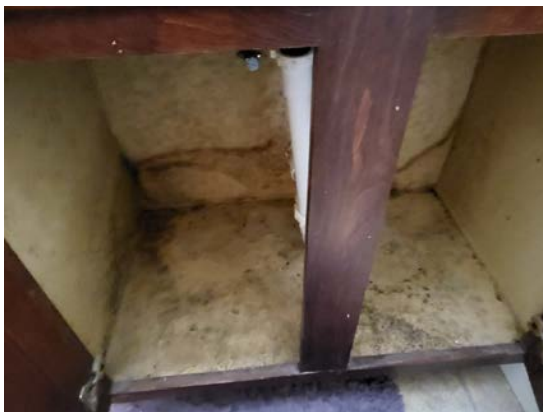
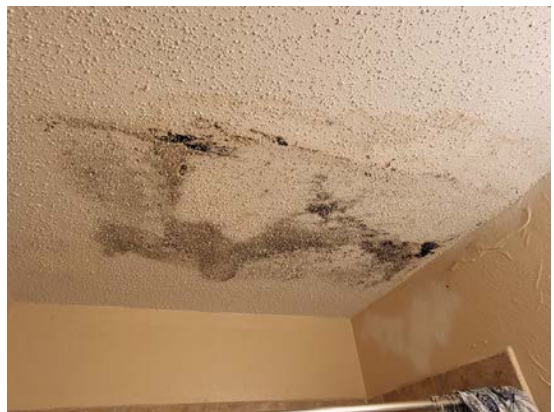
Unit Apparent Microbial Growth

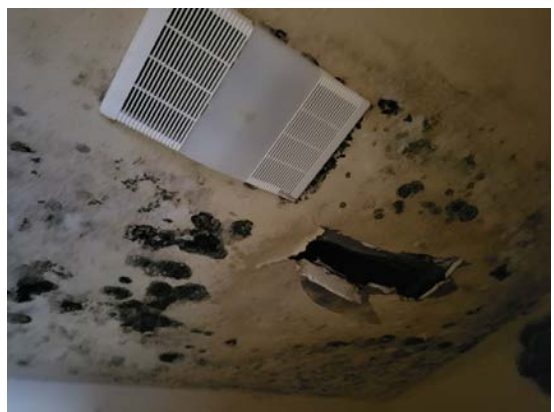
Unit 118 Microbial Growth
