## Phase I Environmental Site Assessment

October 4, 2023

23329-99

Site Size: 9.729 acres  
 Property Type: Multi-family Apartments  
 Building Size: +/- 317,786

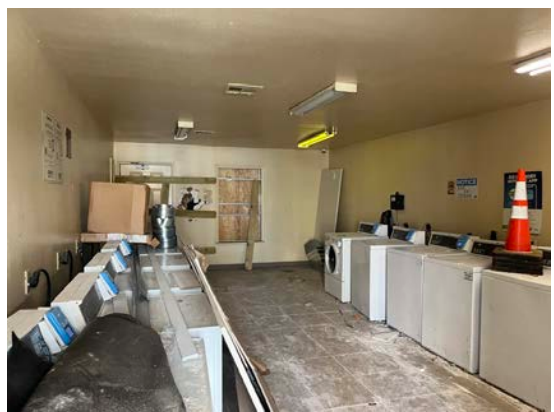
Community Laundry Facility Interior

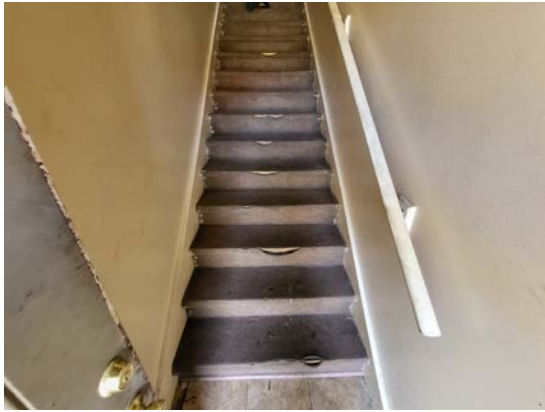
Stairwell to Units

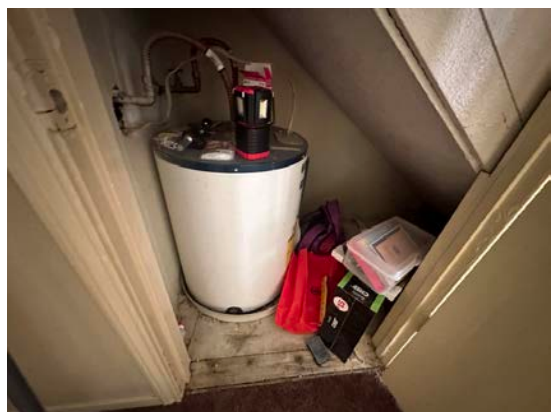
Unit Water Heater

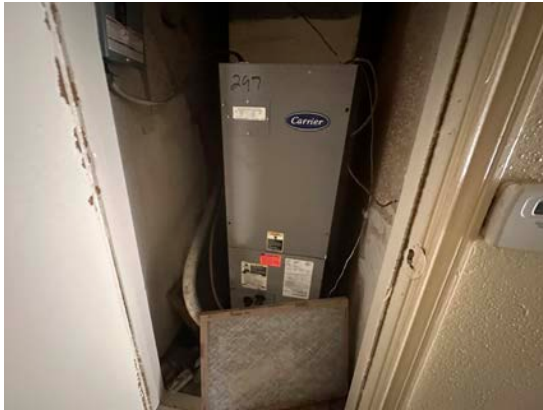
Unit Air Handler
