## Phase I Environmental Site Assessment

October 4, 2023

23329-99

Site Size: 9.729 acres  
 Property Type: Multi-family Apartments  
 Building Size: +/- 317,786

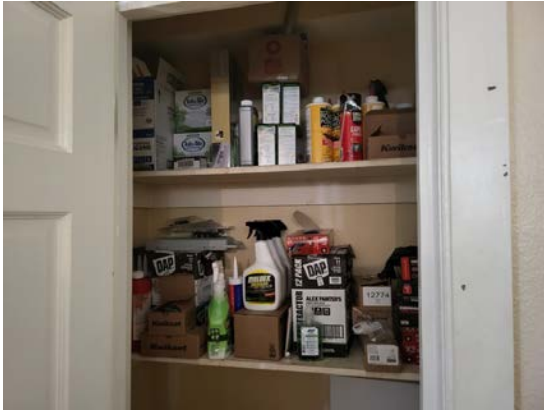
Some of the identified materials appear to be properly stored; however, small quantity flammable should be placed in designated flammable cabinets which was not observed during the time of the assessment. No evidence of spills or staining was observed. The materials observed do not appear to pose a hazard to the Subject Property, provided they continue to be used as designed, are properly handled, and all regulations regarding their use are followed. No further action or investigation is recommended regarding the use of hazardous substances or petroleum products at the Subject Property.

Routine Maintenance Supplies

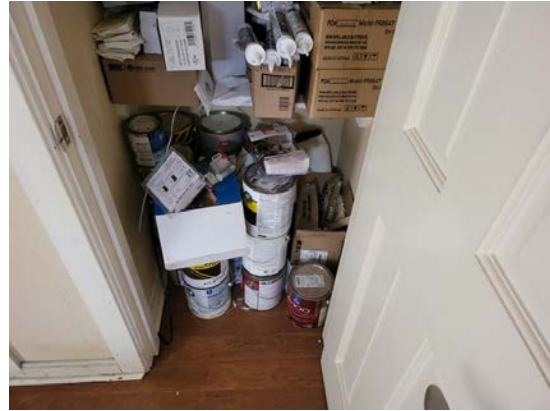
Routine Maintenance and Janitorial Supplies

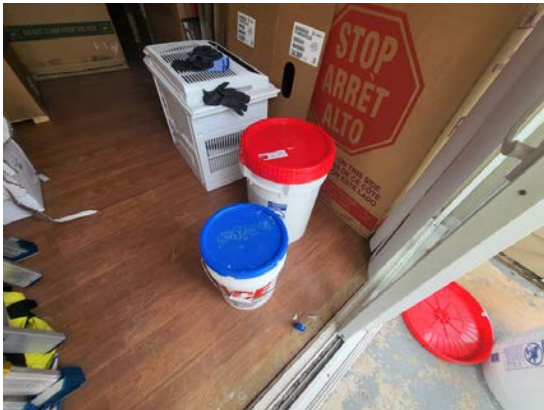
Pool Chemicals

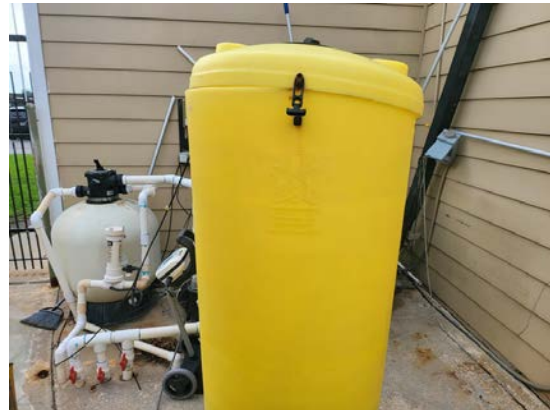
Pool Chemicals

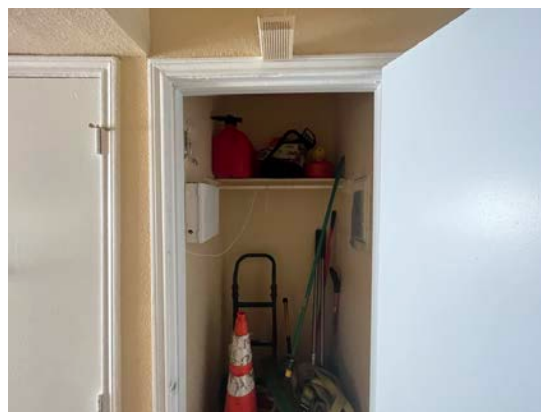
Unit 104 Gas Cans

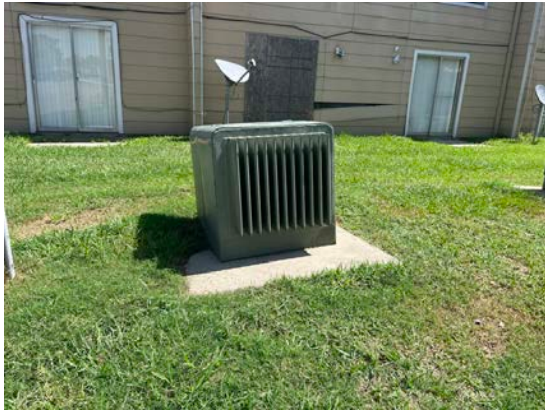
| Report Section | | Acceptable | REC | HREC | CREC | De<br>Minimis | BER | Notes |
|---|---|---|---|---|---|---|---|---|
| 6.1.5 | <u>Transformers or PCB-Containing Equipment/Items</u> | | ✓ | | | | | Concrete staining and distressed vegetation was identified around one transformer in-between Buildings 14 and 16 and is identified as a REC. |

The Subject Property has underground electrical service with pad-mounted transformers owned by [REDACTED], a public utility provider. There was observed apparent leakage from one transformer between Buildings 14 and 16, as evidenced by stained concrete and distressed vegetation around the transformer. This transformer potentially contains PCBs due to its age, as the property was built in 1973. While one transformer had a 2016 manufacturer date, no dates were found on the smaller, older-looking transformers. [REDACTED] could not confirm if the smaller transformers contain PCBs. Since the absence of PCBs within the transformer could not be confirmed, it represents a Recognized Environmental Condition (REC). MCC recommends the identified release of dielectric fluid be reported to [REDACTED] and that [REDACTED] determine the manufacturing date and conduct appropriate response actions to remove the impacted concrete pad and any underlying impacted soil. If PCBs are present, MCC additionally recommends that post-excavation confirmatory soil samples be collected and analyzed for the presence of total petroleum hydrocarbons (TPH) and polychlorinated biphenyls (PCBs). Periodic inspections of other units for leakage are recommended. No other equipment using dielectric or hydraulic fluid was found during the site assessment.

Transformer

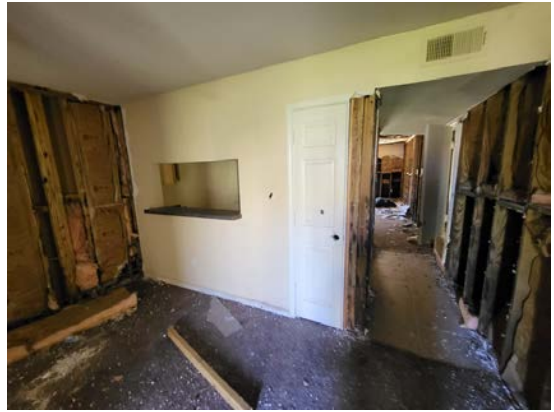
Down Unit 263

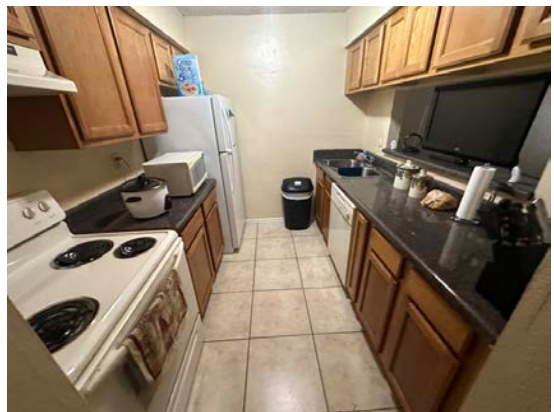
Unit Kitchen

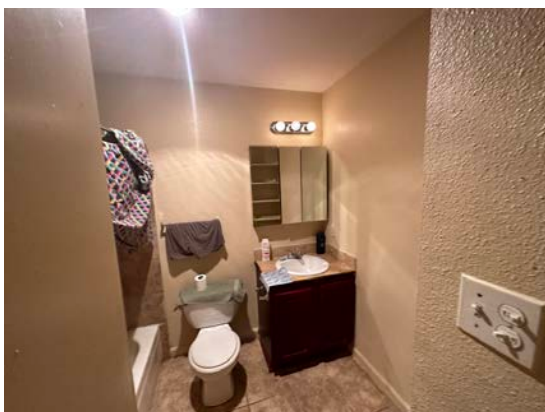
Unit Bathroom

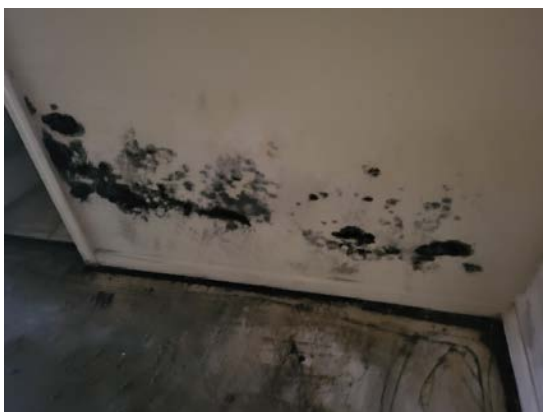
Unit 118 Microbial Growth
